WOODLAND RESERVOIR DAM

PHASE I INSPECTION REPORT

NY 00412

Date of Inspection June 5, 1978

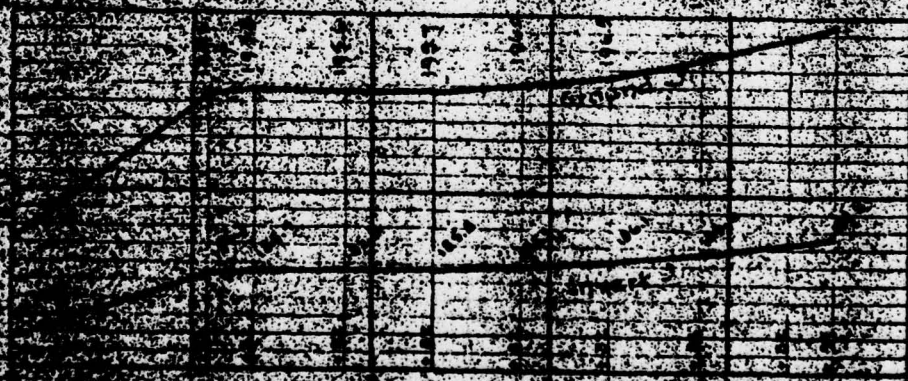
FIGURE 5

According to the report entitled "Relining Woodland Reservoir with Gunitite - 1932" (See Appendix), in January 1932 seepage was observed flowing from the northwest toe of the downstream slope. The reservoir was drained, piezometers were installed in the embankment, the concrete lining was inspected and pressure tested and a full scale leakage test was performed to determine the source of seepage. The conclusion of this investigation was that, sic, "the concrete lining was structurally sound but very soft and porous." The reservoir was subsequently lined with about 1½ inches of gunitite and a 6-inch underdrain installed along the northwest toe of the downstream slope.

GUNDER DRAIN AT TOE OF THE
EMBANKMENT AT WOODLAND
RESERVOIR

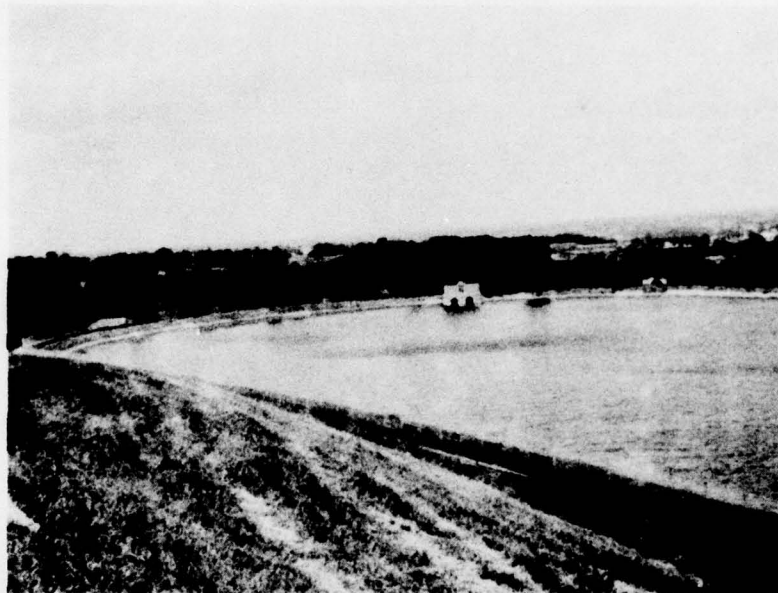
c. Gatehouses - The brick masonry structures appeared to be in excellent condition. The gate valves within the structures appeared to be well maintained, but were not operated during the inspection.

NORTH GATEHOUSE
